Preliminary Research Report on Canon 580EX II Flash Failures

By Jim Clark & Tim Ambrose, Research and Development

LPA Design

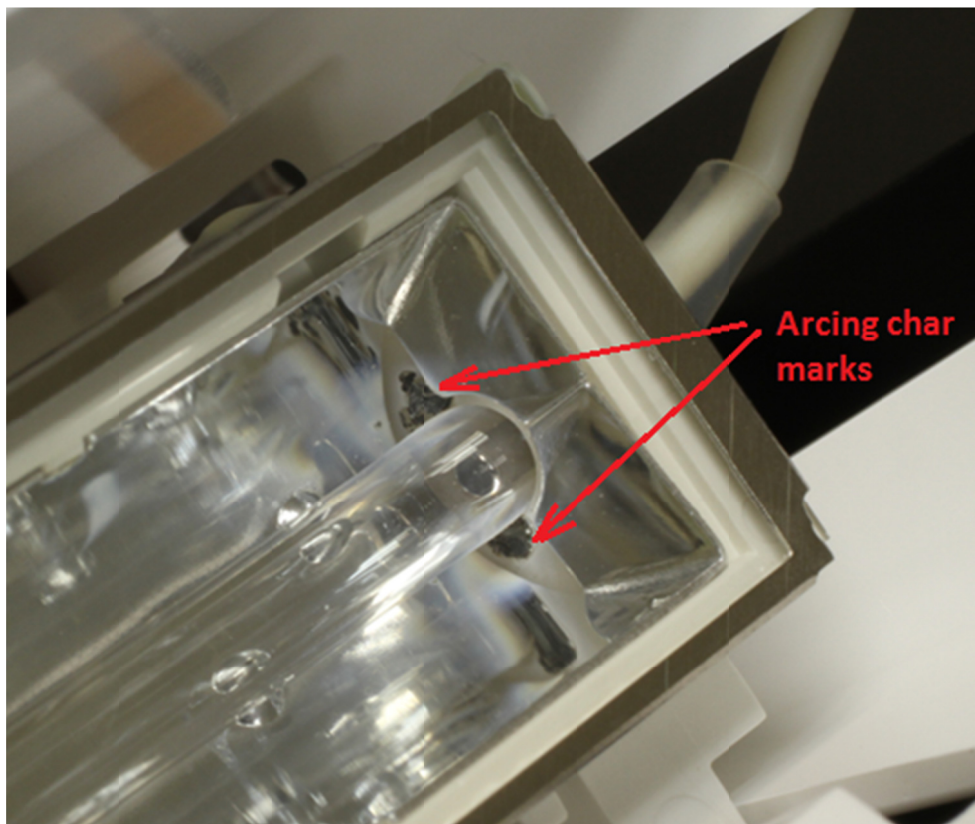
Eventually we found that the flash head (tube/reflector) was also bad and showed visible signs of ash and soot buildup around the ends of the flash tube. Sparks and electrical arcing were apparently taking place.

Figure 1: Flash tube end showing black soot behind tube on rubber mount. Also shows possible oxidization of metal reflector near rubber end seal.

Replacement of the flash heads solved the failure problems and the flashes could no longer be made to fail with or without a PocketWizard radio.

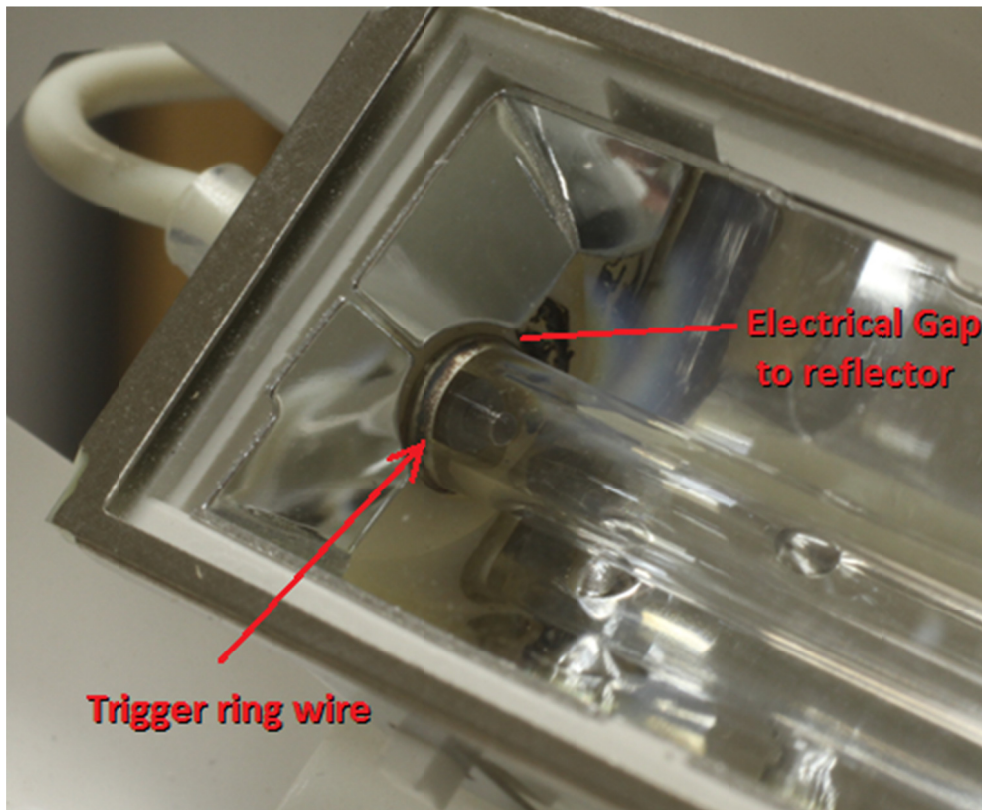
Figure 2: Flash tube end with trigger ring showing black soot behind tube on rubber mount. Also shows possible oxidization of metal reflector near rubber end seal.

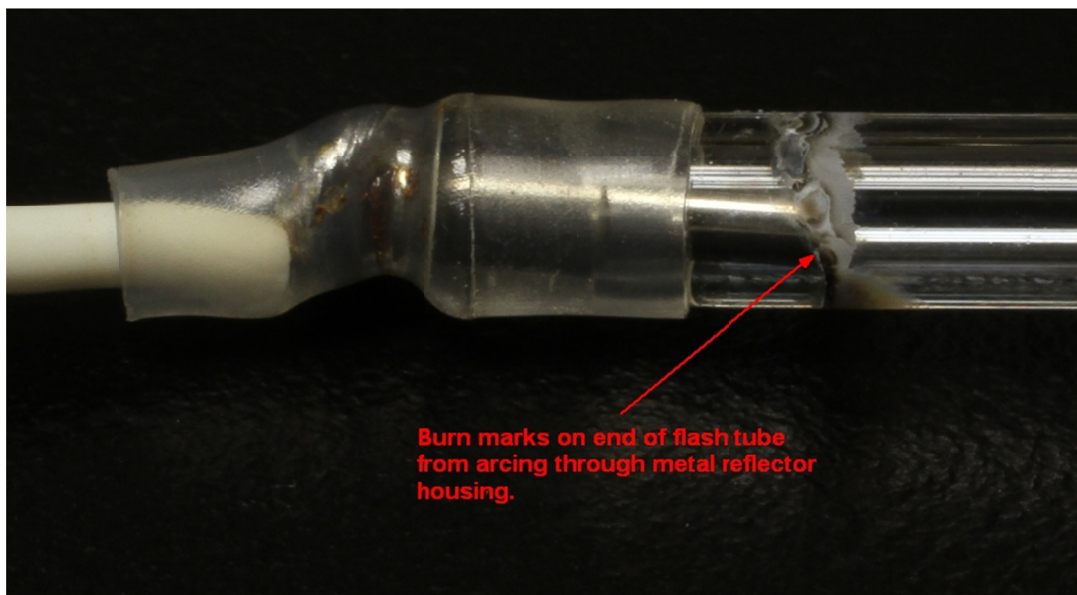
Figure 3: In more severe cases the flash tube glass is charred in a ring around where the metal reflector housing is near the tube.

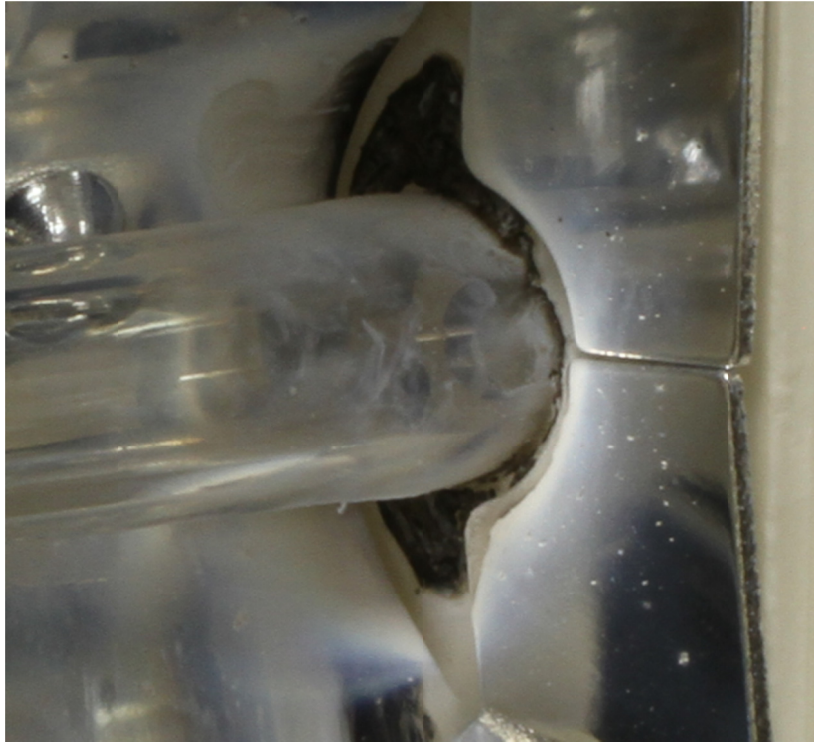
Figure 4: Another example of soot and electrical damage at end of flash tube.

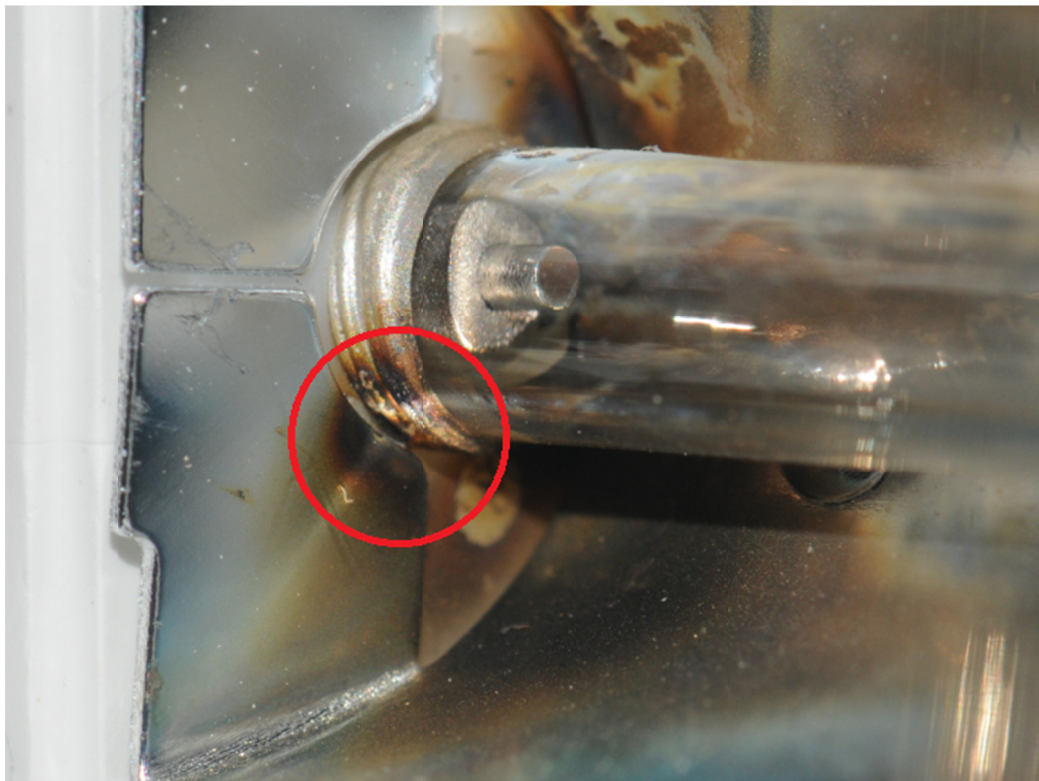
Figure 5: Example of damage from reflector to trigger ring after electrical arcing

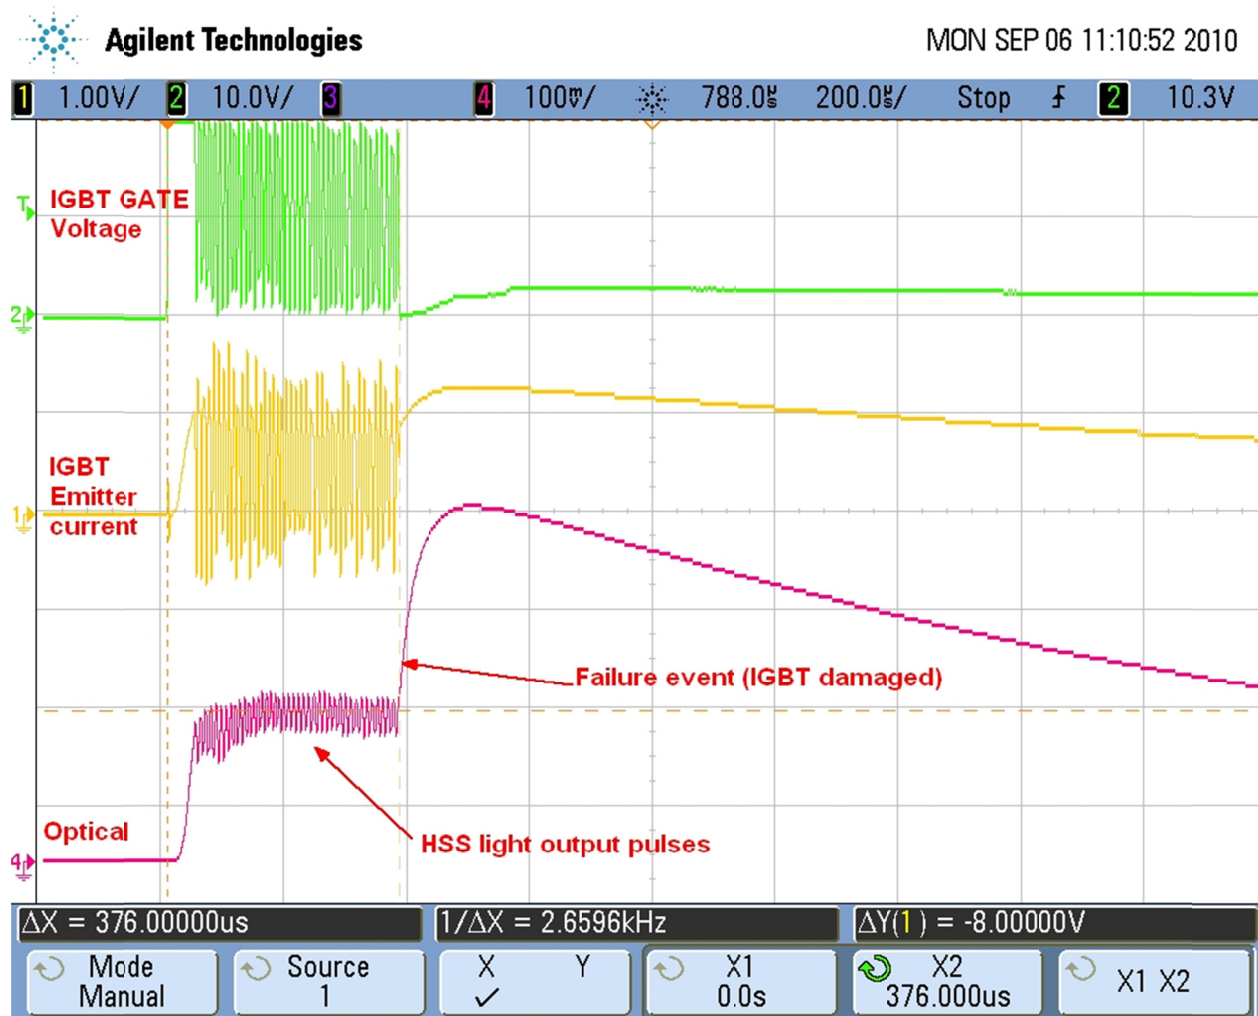
Figure 6: In the middle of a High Speed Sync pulse train, the IGBT fails and shorts Collector to Emitter.

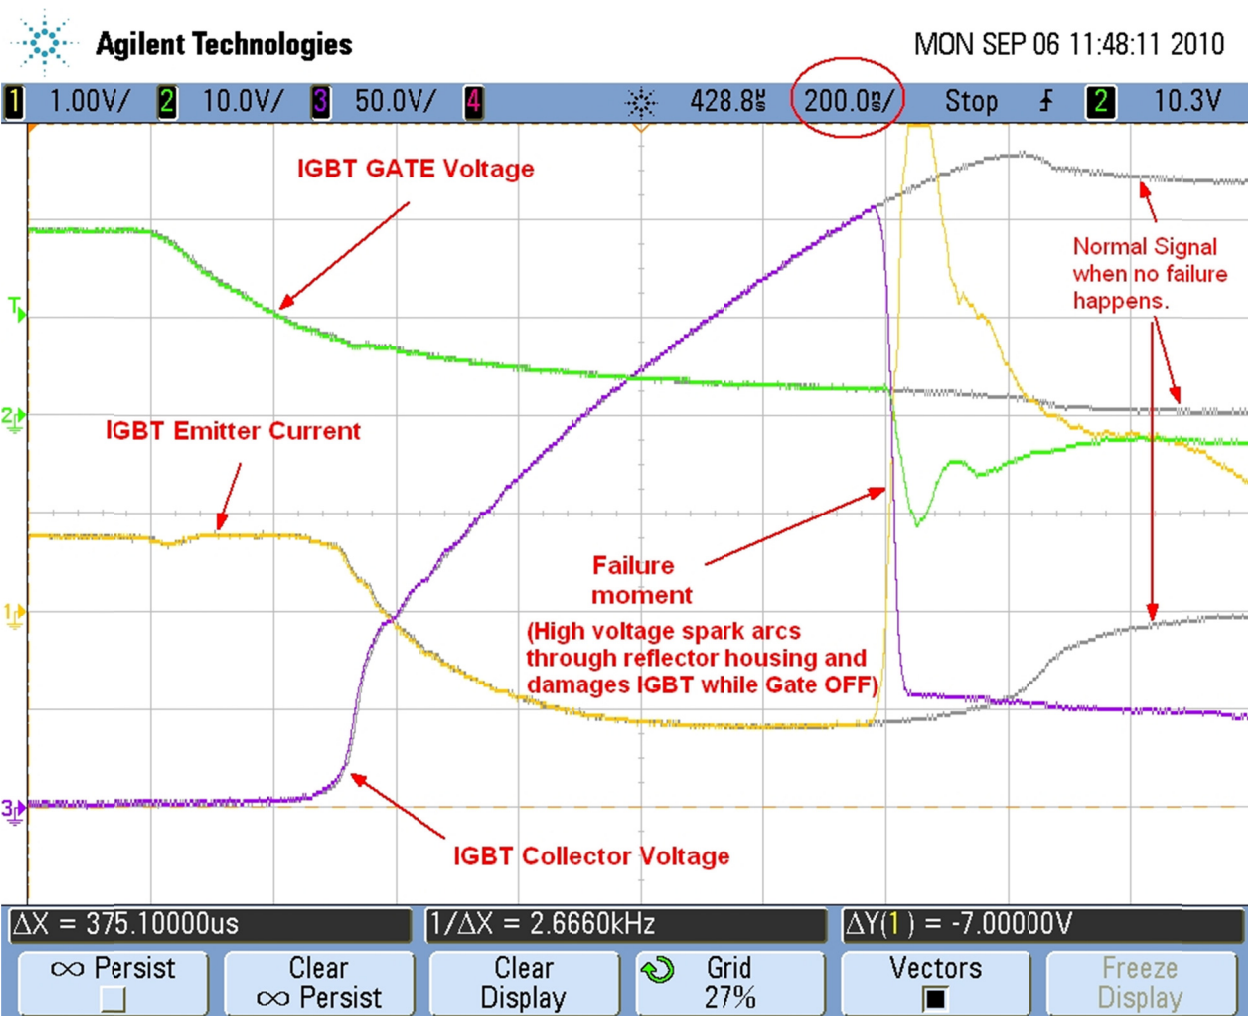
Figure 7: Close up view of IGBT electrical signals. Note that the IGBT gate was turning off when the spark jumped to the reflector and then into the collector of the IGBT.

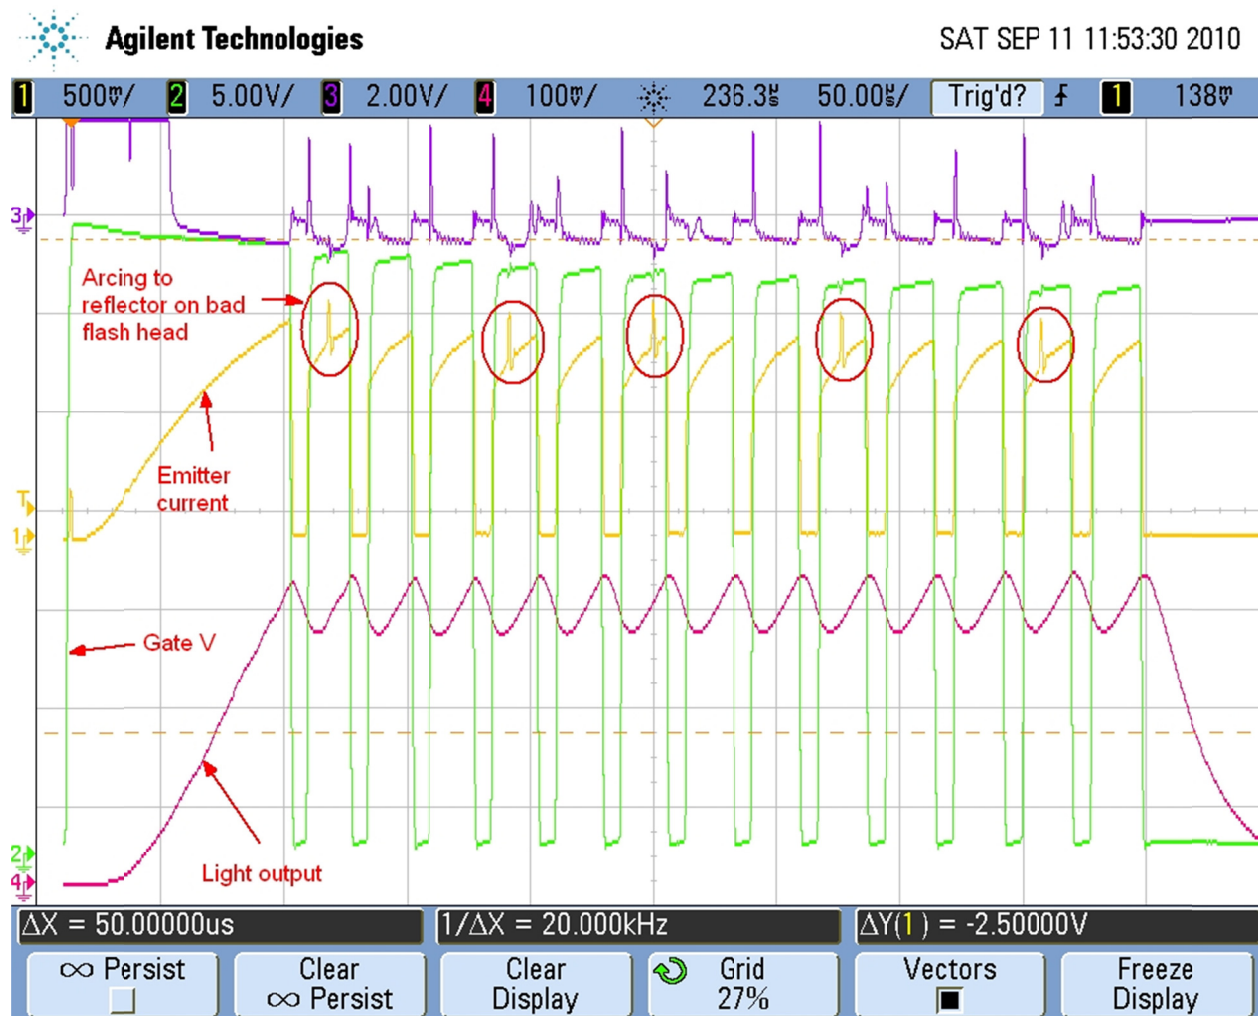
Figure 8: Short current spikes on IGBT emitter caused by arcing to reflector or trigger ring.

Note: Top trace is the control line going to the trigger coil driver circuit.

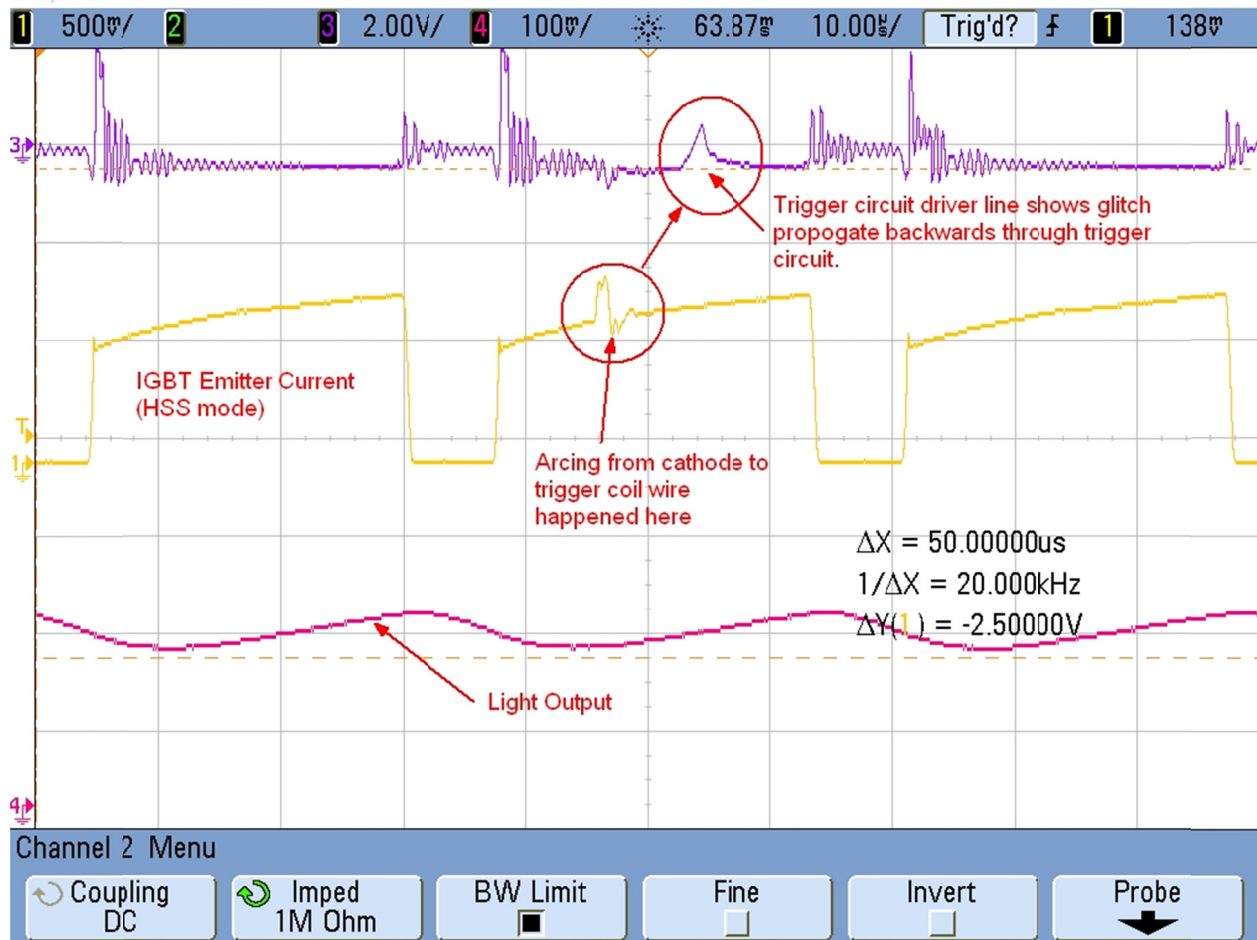
Figure 9: Same as Figure 8 (zoomed in) Short current spikes on IGBT emitter caused by arcing.

Note that the arc pulse to the trigger ring in this case propagates backwards through the trigger coil circuits. (Happens after arc not before which indicates that the control signal did not cause the arcing.)

In theory this figure 9 shows that the flashes electrical control circuits did not cause the trigger coil to fire at the moment that is circled above. This also indicates that it's not a CPU firmware driven event that caused the arcing.

To further confirm that this is in fact arcing to the trigger ring, we placed a 47K ohm resistor in series with the trigger ring and saw a significant reduction in current ringing on the circled event above as well as elimination of the circled pulse on the driver circuit line (top trace).

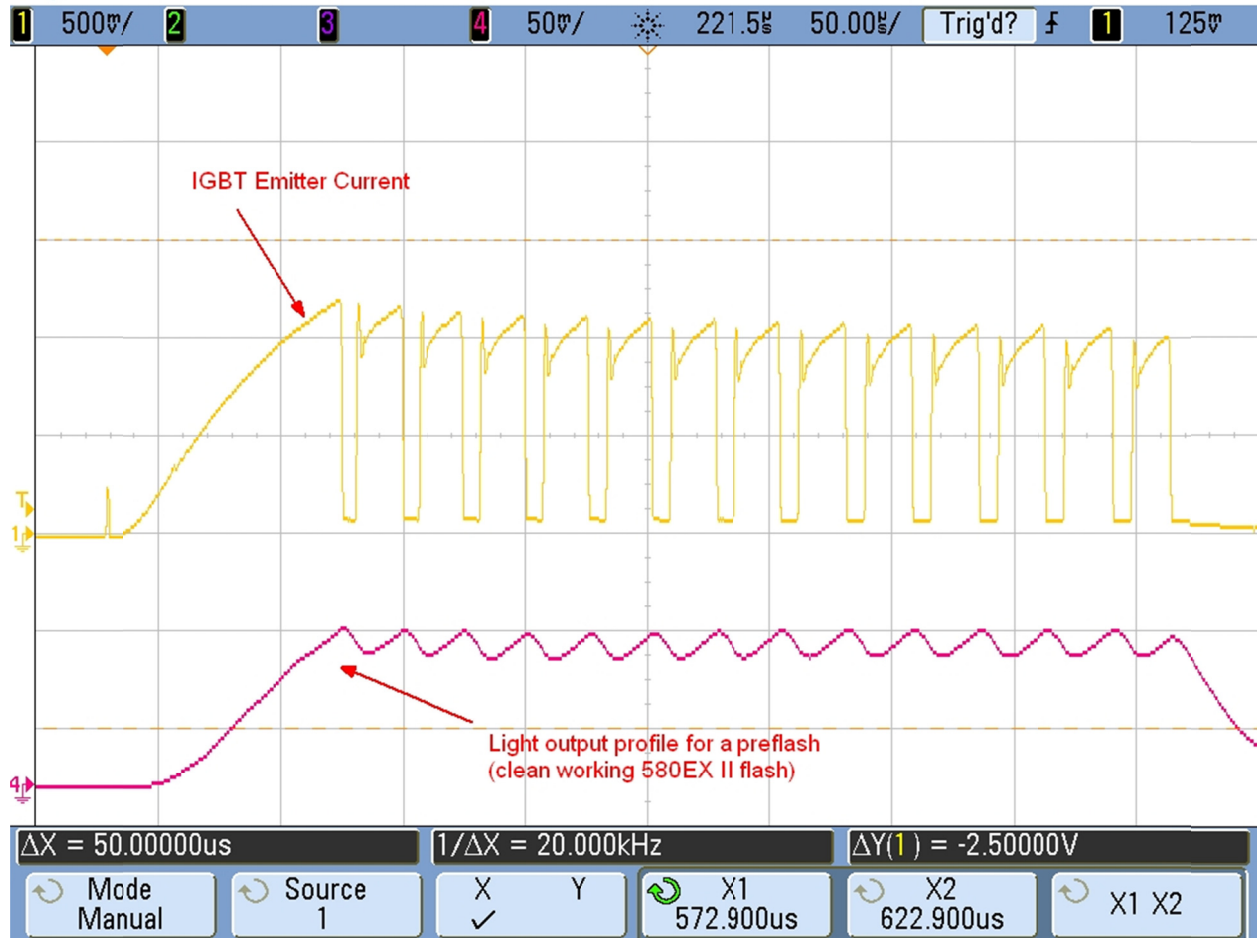
Figure 10: Typical trace showing a pre-flash (while using a PocketWizard MiniTT1 / FlexTT5) to trigger the 580 EX II on a good working flash that does not damage IGBTs.

Note that the current profile does not have any spikes in the middle of the IGBT ON periods.

This flash has a good positioning of the fiber optic and no signs of kinks or bends in the fiber.

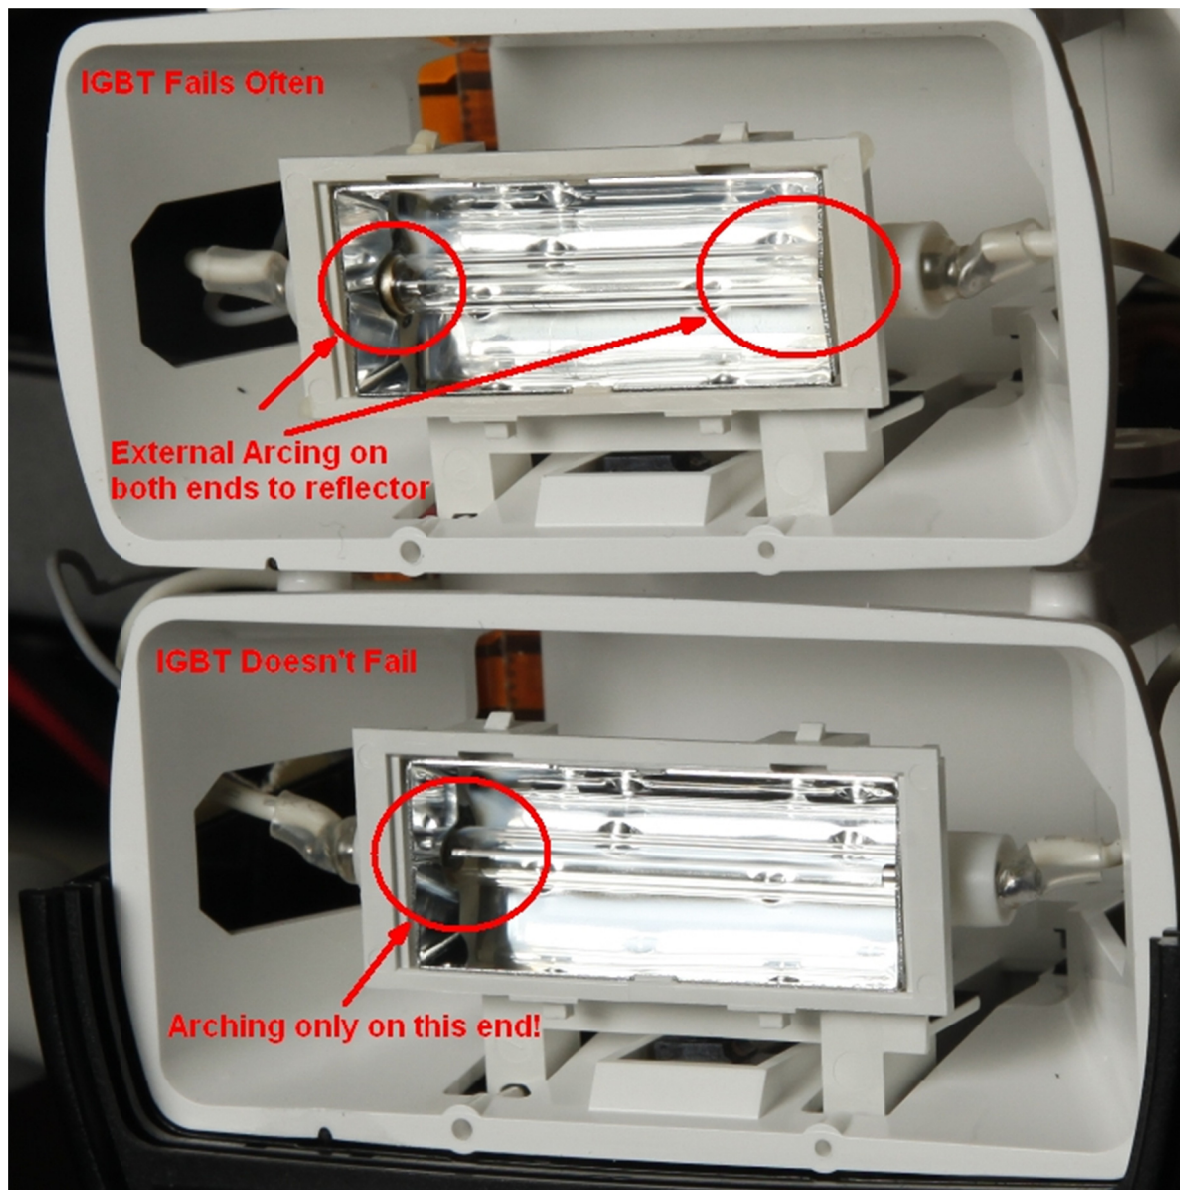
Another significant observation is that flashes that have the flash tube aligned with the trigger ring extending into the reflector are more prone to fail again.

One theory is that this tube trigger ring positioning (top image) makes the spark gap distances to the metal reflector the shortest thereby enabling arcing to happen much easier.

Manually moving the flash tube shown on bottom image to the right such that the spark gap was shortened did increase the rate at which arcing occurred. (However it did not cause the IGBT to fail)

We have found that we cannot get the IGBT to fail if the front glass cover is not in place.

Figure 11: NOTE: the sealed glass covers are removed from the head assemblies for easier viewing of the flash tube.

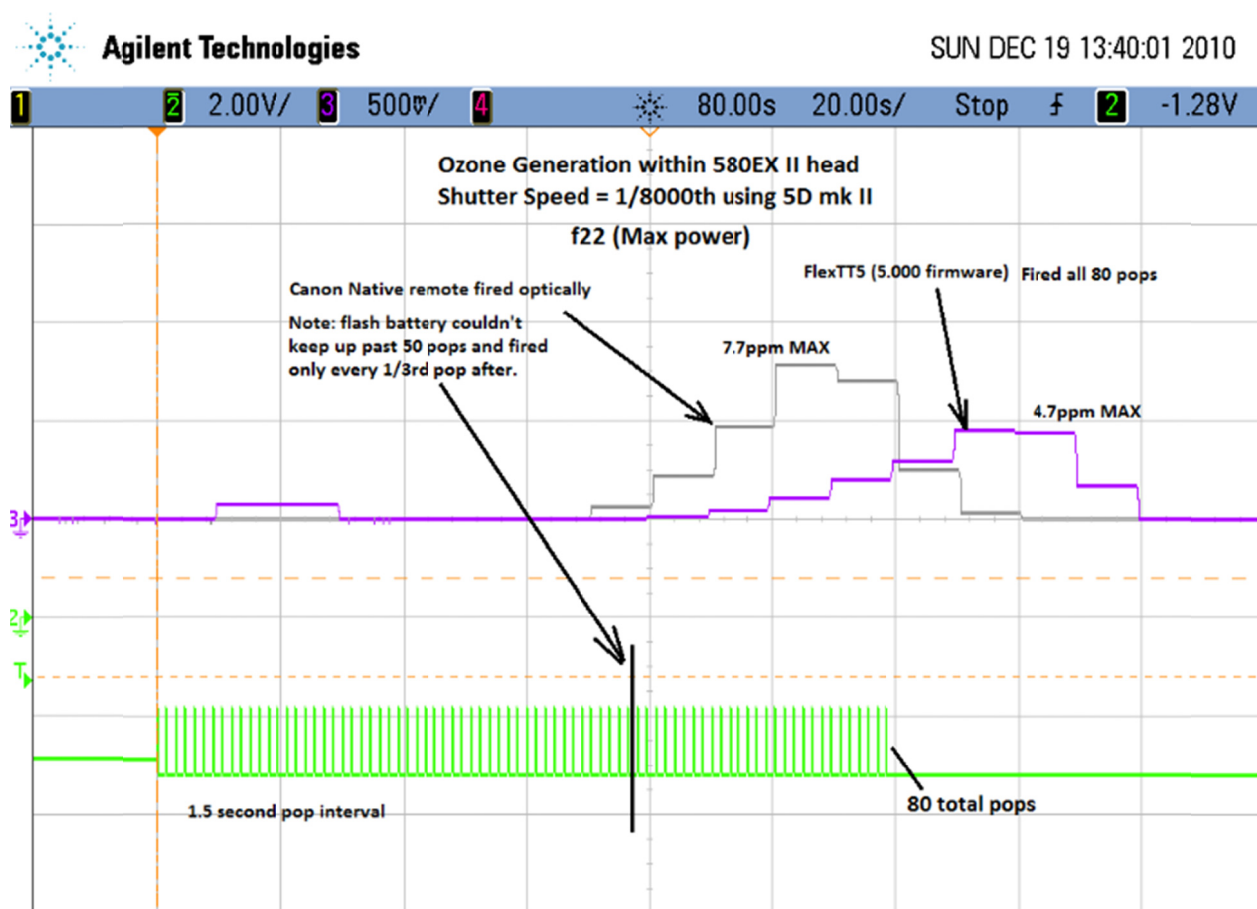
Figure 14:

As can be seen in the scope traces shown in Figure 14, the Canon native system using their own optical triggering has a much faster buildup of Ozone inside the flash head than when the PocketWizard FlexTT5 is used as the trigger. This lower rate of ozone buildup is likely related to the much more energy efficient HSS timing control system used by the PocketWizard ControlTL system.

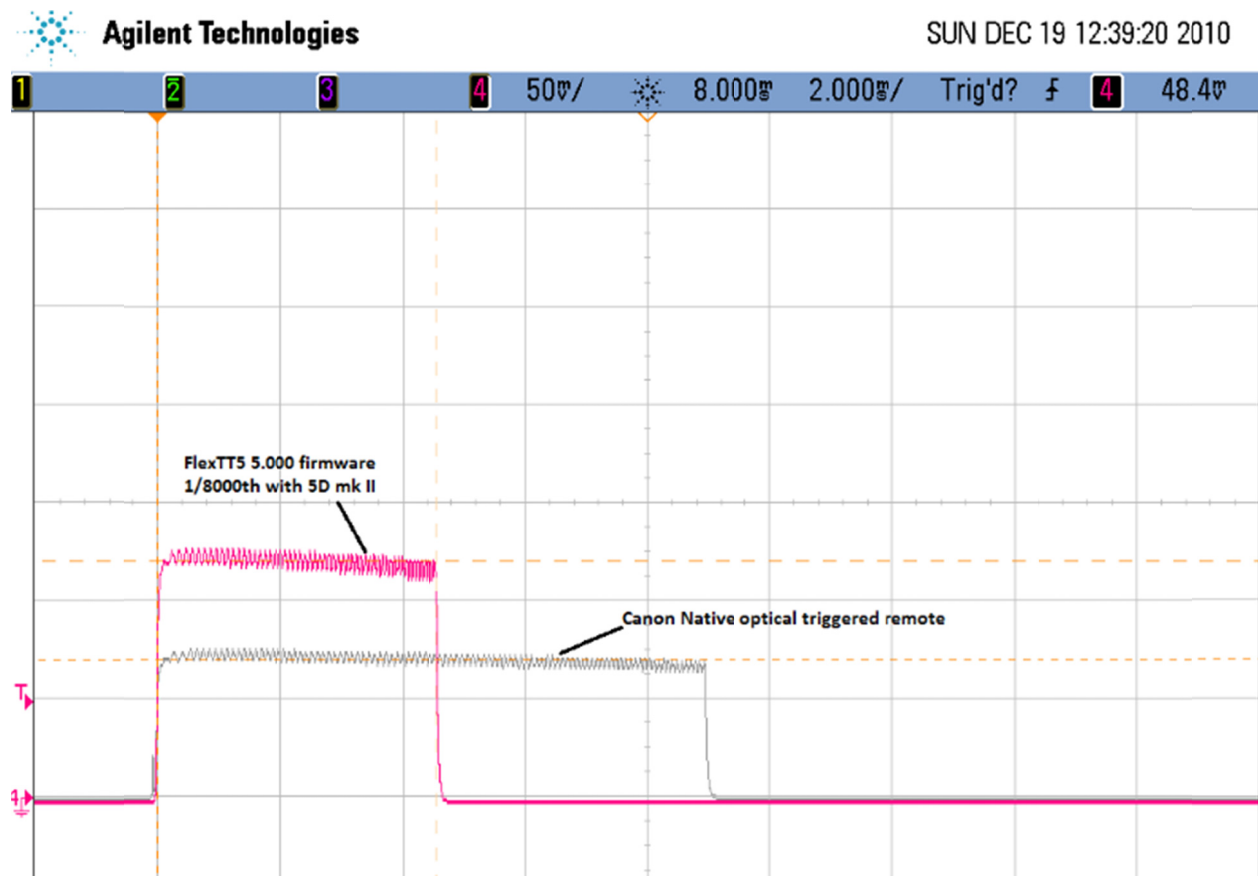
Figure 15: Showing full power HSS light output from 580EX II when fired via Canon's native optical control system. The red trace shows the shorter firing time but brighter maximum output that is possible when using the PocketWizard FlexTT5 as the triggering system.

Since the light output when using the PocketWizard radio was brighter but half the duration, the total energy that was delivered by the flash tube was the same but the resulting ozone buildup inside the flash head was half as much when using the PocketWizard FlexTT5.

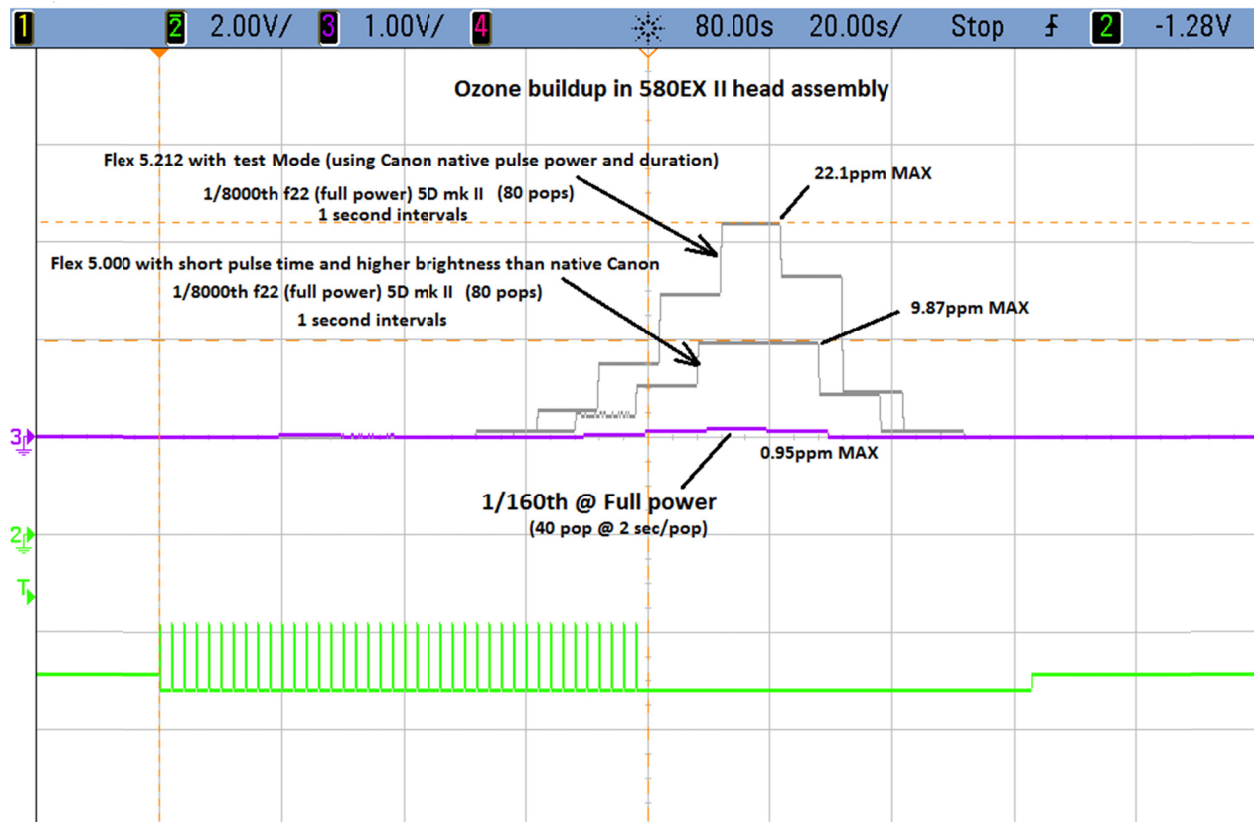
Figure 16: When firing the flash using only a full power dump in non-HSS (below X-Sync) the ozone buildup was nearly zero. However when we tried to duplicate the exact same pulse duration and brightness of Canon's native optically triggered HSS (1/8000th) the ozone buildup was much greater.

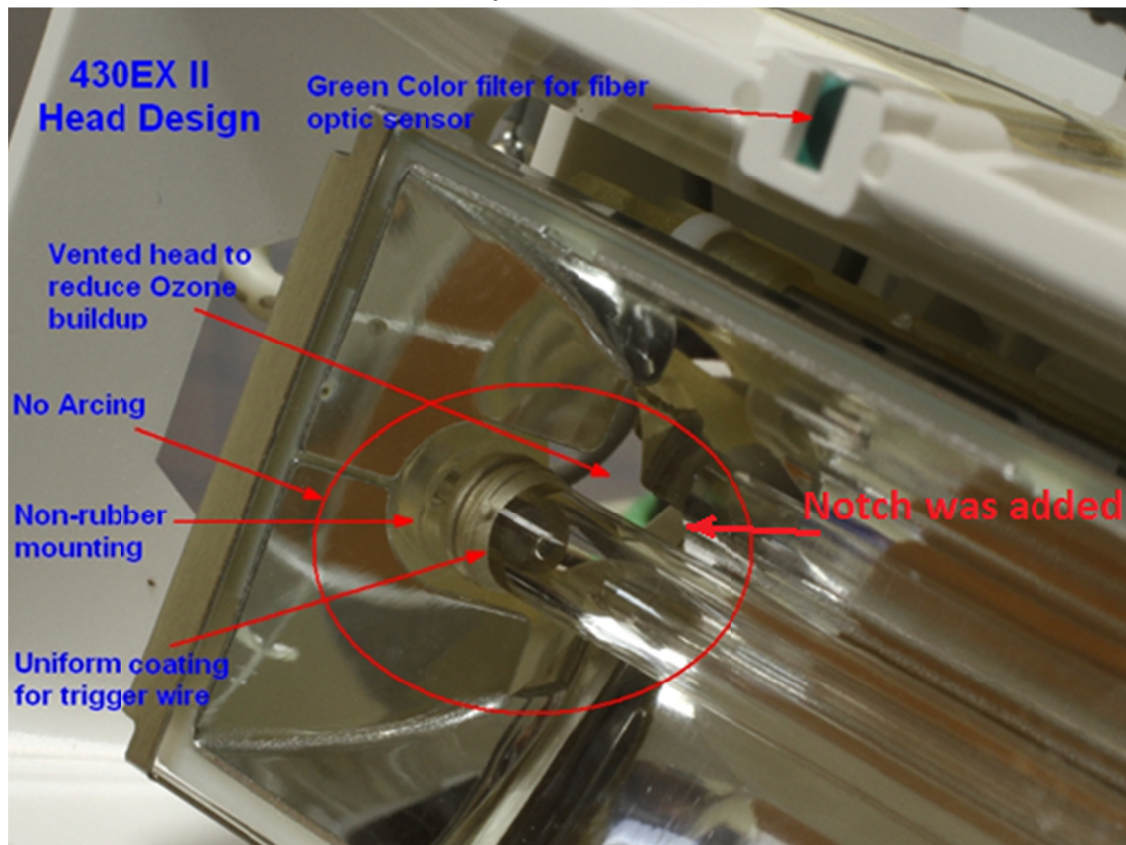
Figure 17: The 430EX II has 3 times more air gap space between the trigger ring wire and the metal reflector than used in the 580EX II. Additionally, a cutout was added directly below the flash tube theoretically for extra venting and clearance from electrical arcing.

The rubber end seal & mount used on the 580EX II is eliminated on the 430EX II.

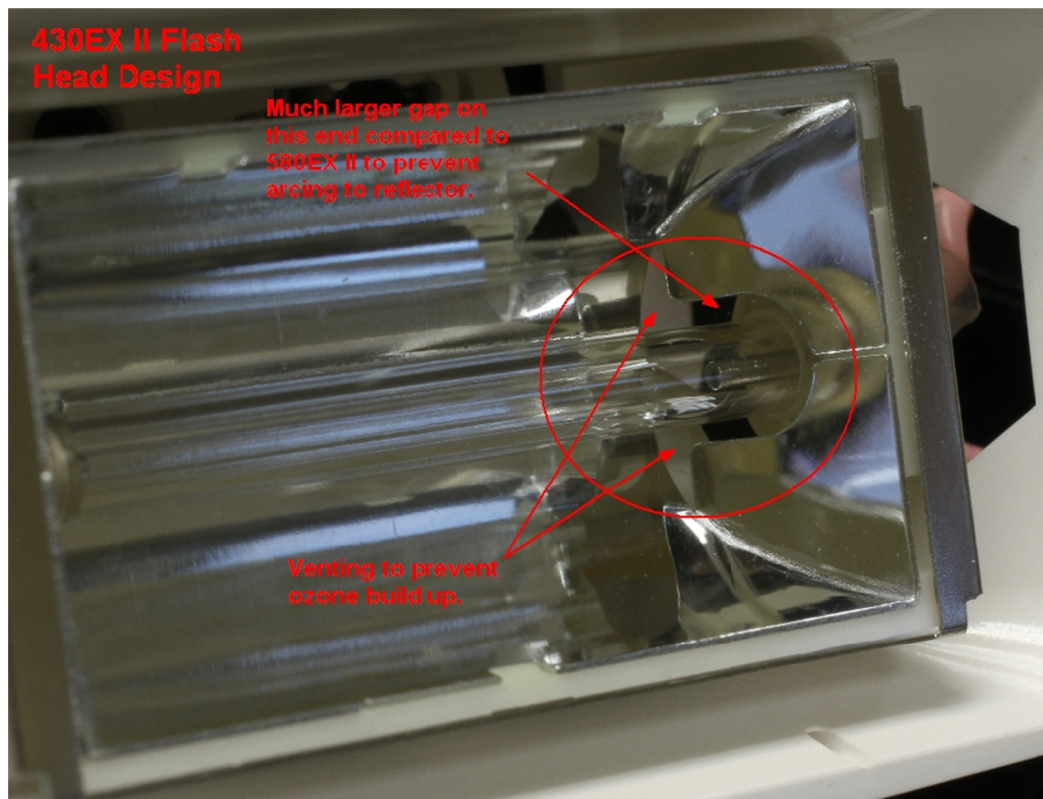
Figure 18: The 430EX II does not use a sealed end cap to hold the flash tube in position like the 580EX II flash uses.
