Preliminary Research Report on Canon 580EX II Flash Failures

By Jim Clark & Tim Ambrose, Research and Development

LPA Design

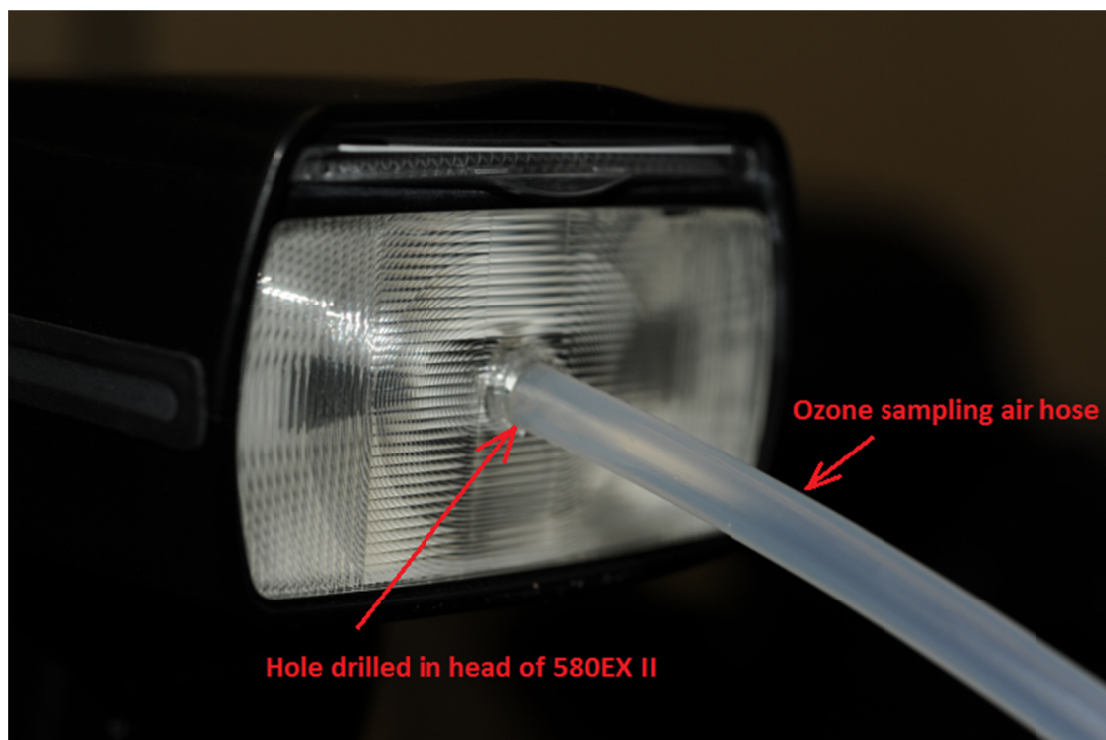
To further test this theory, we removed the glass front cover from a flash head assembly that typically did cause IGBTs to fail. With the glass cover removed, we can't get the IGBT to fail.

Figure 12: This 580EX II had the glass cover removed from the internal flash head assembly so that Ozone gas could be sampled via the front of the housing through the plastic Fresnel lens.

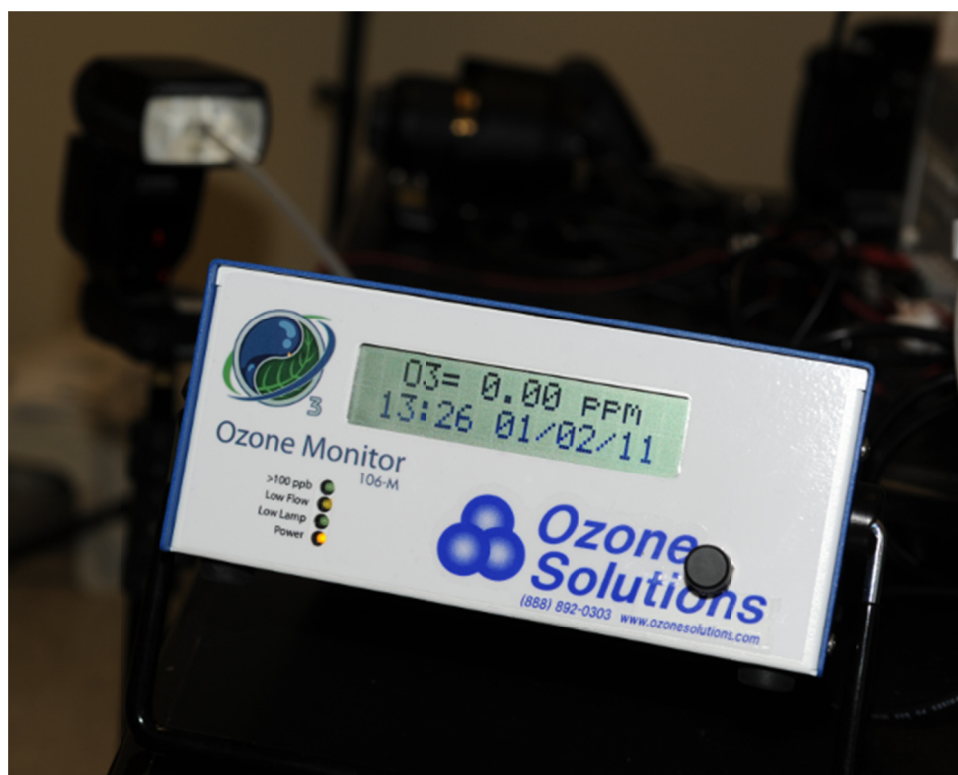
(Model # 106-M) The model 106-M reads Ozone as low as 10ppb (10 parts per billion).

Figure 13: Ozone Solutions Gas analyzer model 106-M
